VLF 'PULSE SWITCHING' REPEATED

Clifford E Carnicom

Mar 17 2003

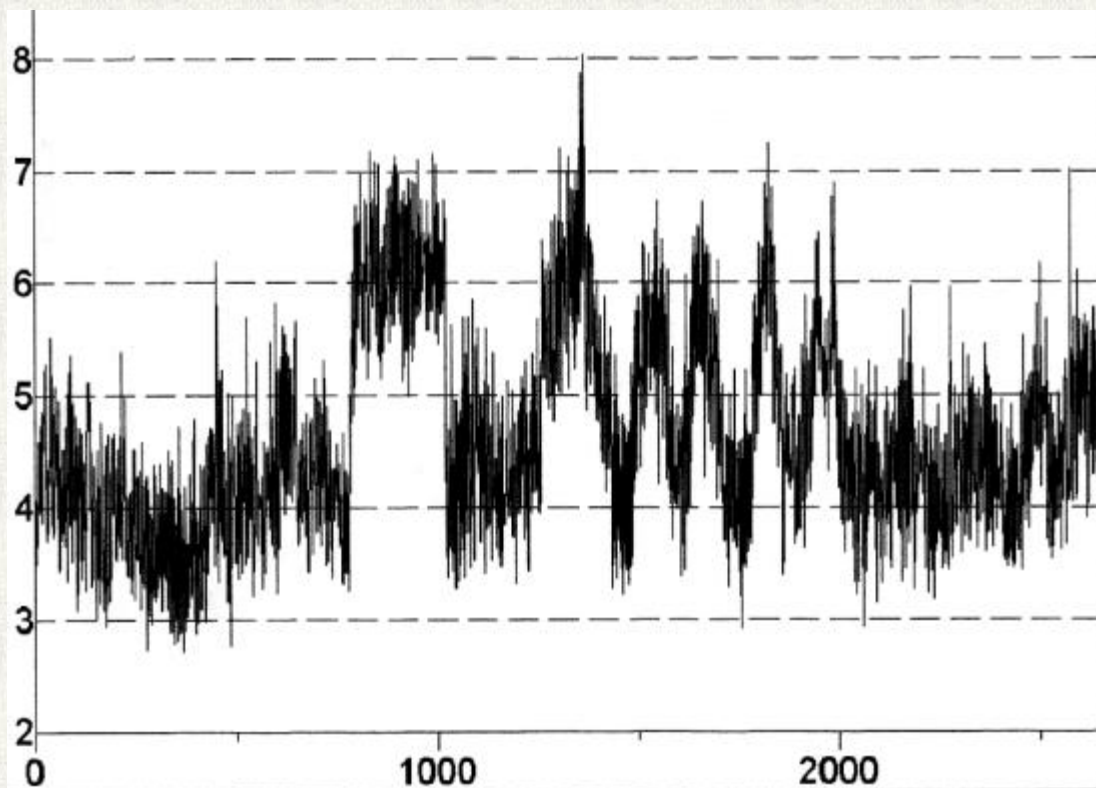
**Very Low Frequency 'Pulse Switching' Observed and Recorded
Santa Fe NM 031503 at approx. 1430.**

X Axis : Observation Number (1 Observation per second)

Y Axis : Frequency of Monitoring in Kilohertz (kHz)

A pattern of anomalous Very Low Frequency (VLF) has again been detected and recorded. This session occurred on Mar 15 2003. The baseline reference value for monitoring was approximately 4-5kHz. At observation number approx. 750-800, a sharp increase in the received frequency occurs. This increase remains for approx. 200 seconds, then a sharp decrease in the frequency level occurs. After approximately another 200 second period, an alternating sine wave variation in frequency level occurs for approx 800 seconds and then ceases.

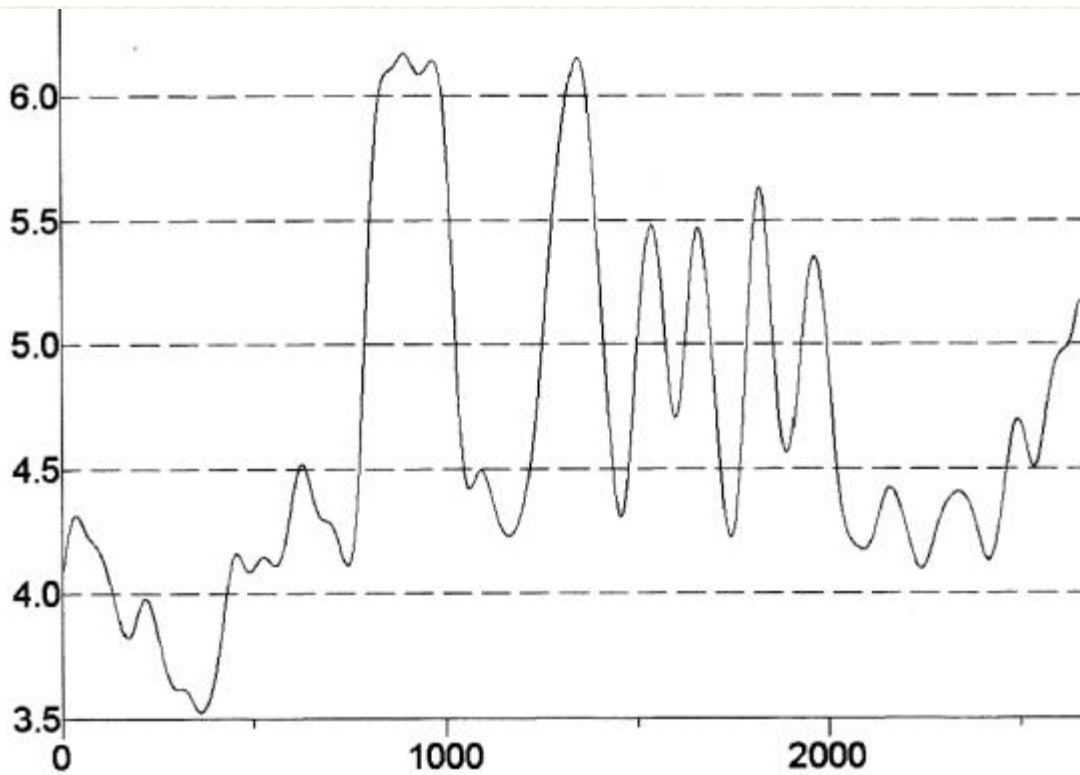
**Digital Filter Applied to VLF 'Pulse Switching' Data
Santa Fe NM 031503 at approx. 1430.**

X Axis : Observation Number (1 Observation per second)
Y Axis : Frequency of Monitoring in Kilohertz (kHz)
